Following the 2011 fire at the Diamant Hotel in Canberra, which caused over \$10million in damage, Allianz Insurance instructed GKA Investigations Group to examine the fire scene and determine the circumstances the cause of the fire.

A PIECE OF CANBERRA'S HISTORY

THE DEVASTATING FIRE

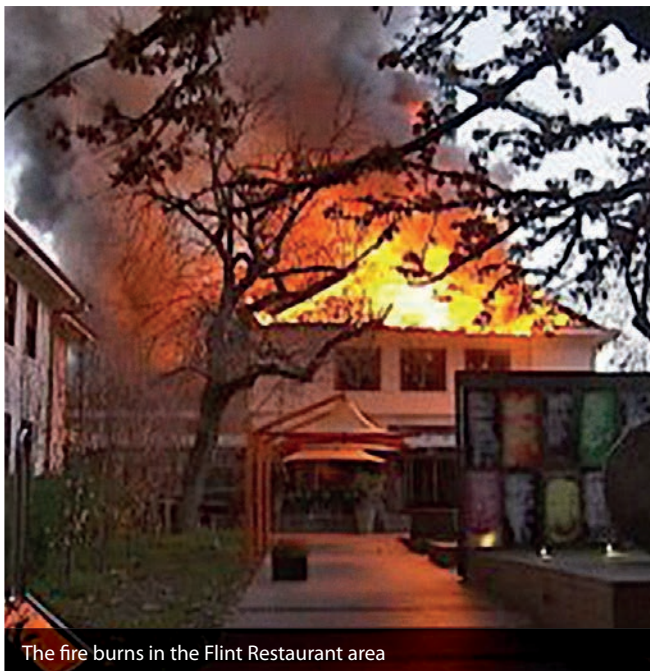
The fire burns in the Flint Restaurant area

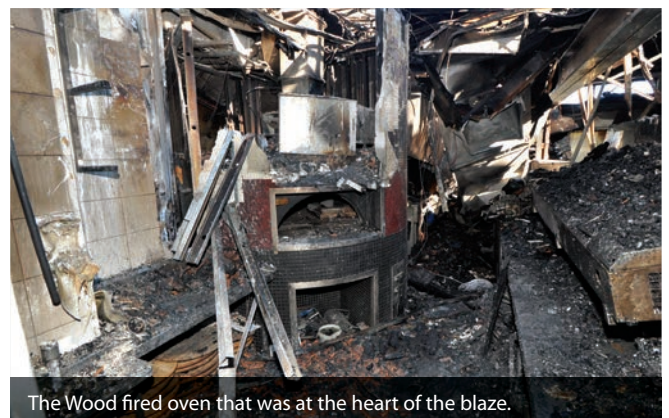
The Wood fired oven that was at the heart of the blaze.

Chief Fire Examiner Greg Kelly headed the site examination and he was able to quickly isolate the dirty exhaust ducts above the pizza oven as the source of the fire.

A spray filter attached to the wood-fired oven to cool gasses entering the ductwork had been turned off by kitchen staff, apparently it caused smoke to come back into the restaurant. It was designed to extinguish any embers floating upwards and drop them into a collection tray. Had it been in operation, it could have curtailed the fire.

The ductwork was concealed by a snugly fitting mezzanine chipboard structure. The proximity of the ductwork to the mezzanine had caused the pyrolysis on the chipboard and clearly the heat from the ductwork was a significant risk for a future fire.

Elements of the exhaust ducts breached the building standards and it was discovered that the ductwork itself was very thin.

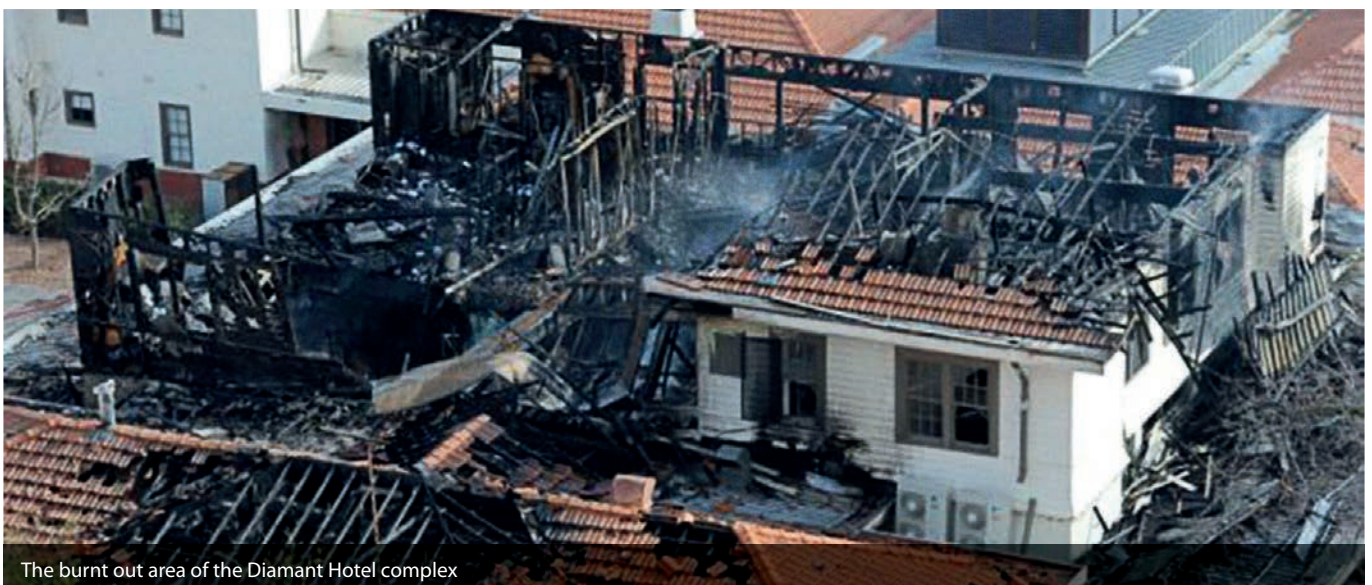
The burnt out area of the Diamant Hotel complex

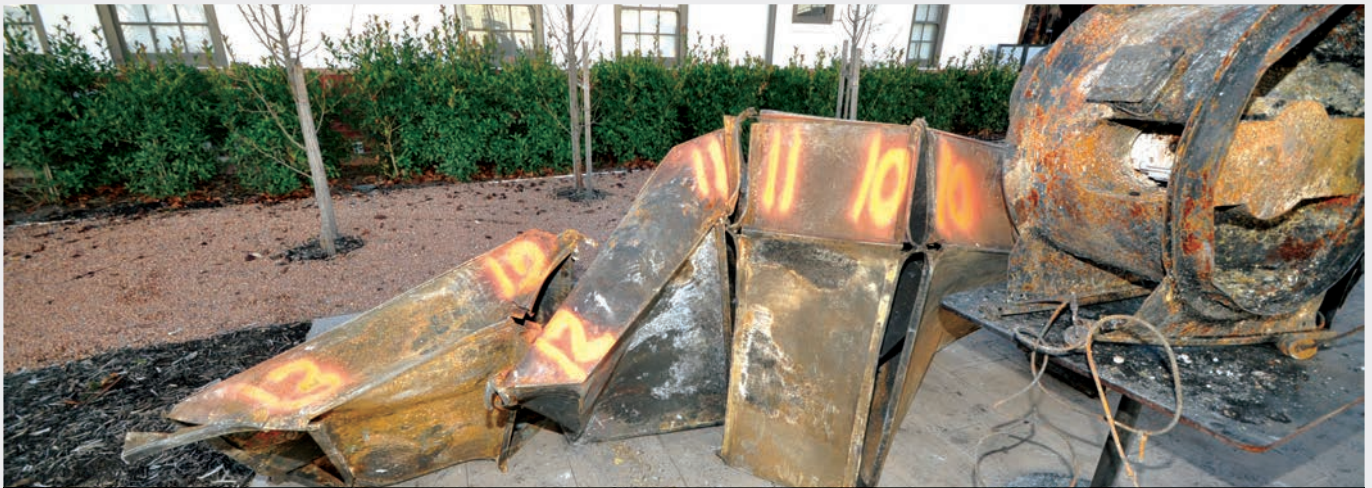
At the request of the ACT Coroner, the ductwork was reassembled so that the Court could fully understand the circumstances of the fire.

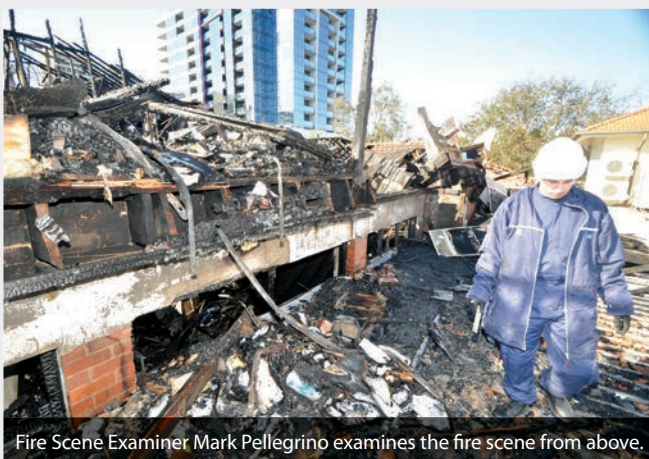
Fire Scene Examiner Mark Pellegrino examines the fire scene from above.
